**DATA STRUCTURE: WATCHING BRIEF ON THE MACHINE EXCAVATION
OF SITE INVESTIGATION PITS AROUND LISMORE PARISH CHURCH, ISLE
OF LISMORE, ARGYLL**

Client: Kilmoluag Liosmor (SCIO, Registered No SC053097)

Produced by Clare Ellis of Argyll Archaeology, January 2025

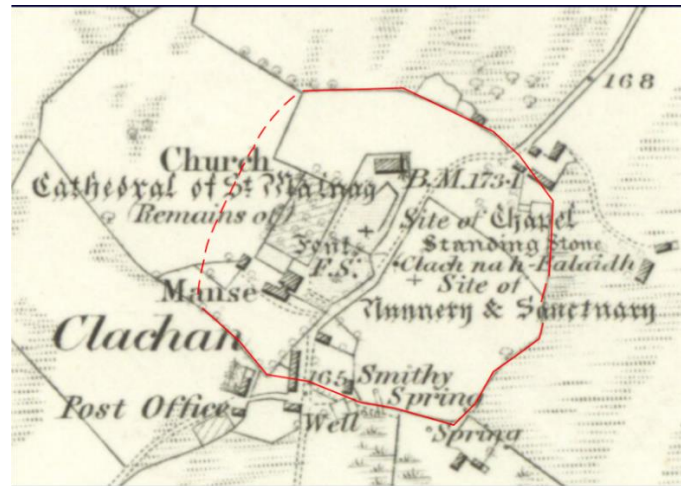
- 1.1.1 Lismore Parish Church is the choir of the medieval cathedral of Argyll and sits on the purported site of a monastery founded by St Moluag (c. 592 AD). A large curvilinear enclosure, visible in the line of old boundaries and which surrounds the parish church and the settlement of Clachan, encloses an area of roughly 4.5 hectares and has been interpreted as the remains of a monastic vallum (MacDonald 1974) (Fig. 2).

Fig. 2. Possible line of the vallum monasterii (after MacDonald) shown in red, over 1st Edition Ordnance Survey Map Sheet LXXII 1875

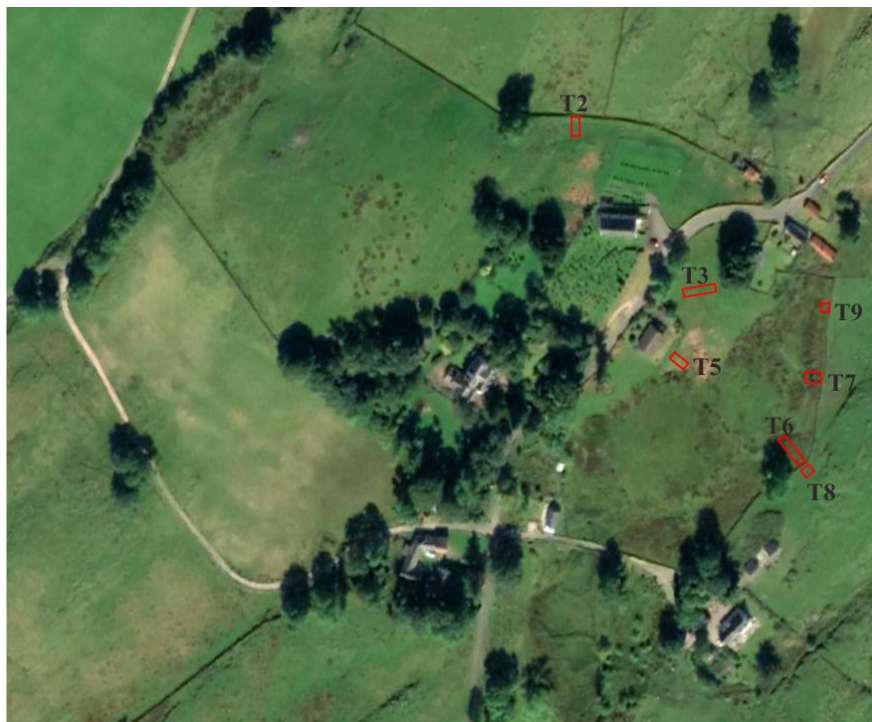
- 1.1.2 However, until 2018 the only evidence of early medieval activity within the glebe was the fragments of an 8th century cross which were found in the graveyard. But now because of the community led pilot excavation within the glebe lands in 2018 we can be confident in the existence of an enclosed cemetery dating from at least 7th century and earlier burials may well exist (Ellis 2019) (Fig. 3 & 4).

Fig. 3. Location of the evaluation trenches, 2018 excavation

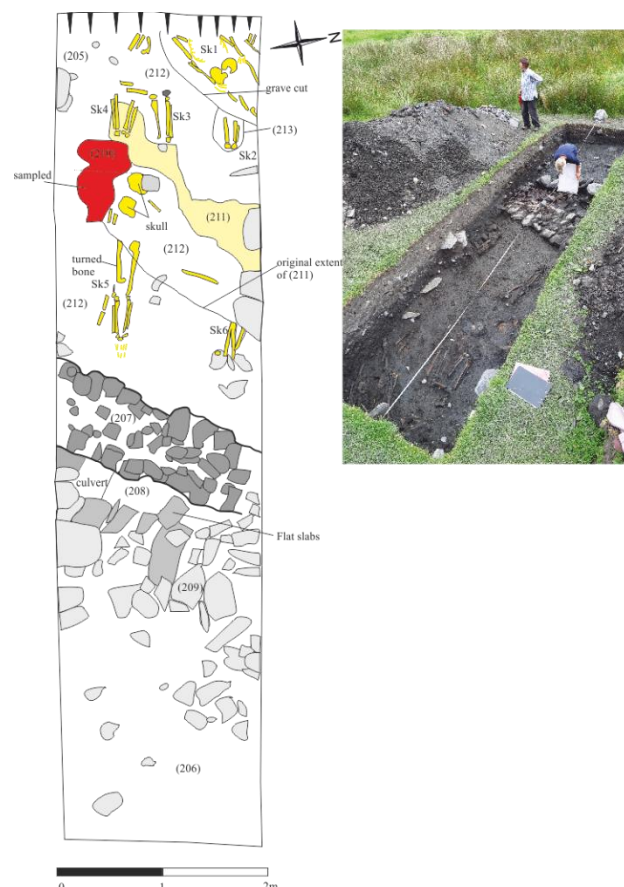
Fig. 4. Trench 5, the cemetery excavation.

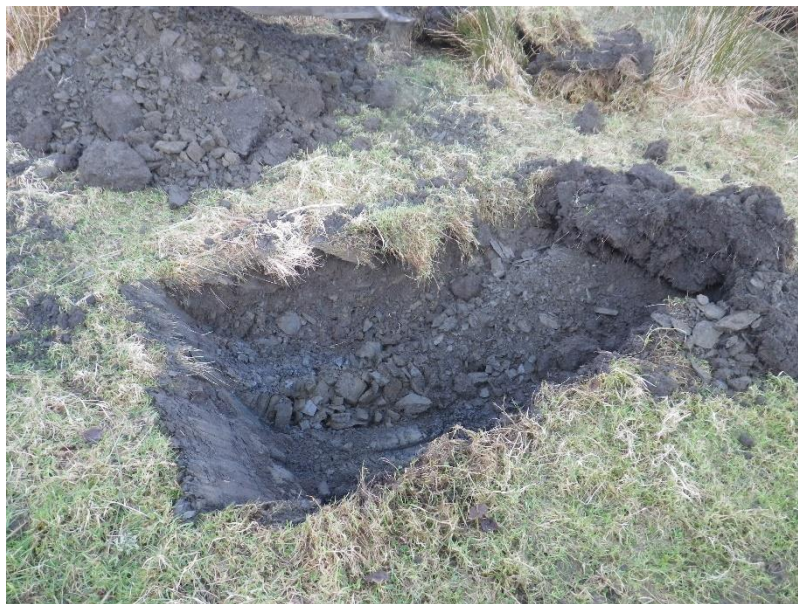
Fig. 7. TP1

- 4.1 TP1 was located on the west side of the modern graveyard and its western fence and just beyond the scheduled area and to the east of the banked enclosure (Fig. 1 & 7). The test pit measured 1.70m NE/SW and was 0.90m wide SE/NW. The topsoil comprised a dark grey clay loam around 0.23m deep. Below the topsoil was shattered limestone bedrock which was soft and easy to excavate. The trench was excavated down to a depth of 1.4m. No archaeological deposits or artefacts were found.

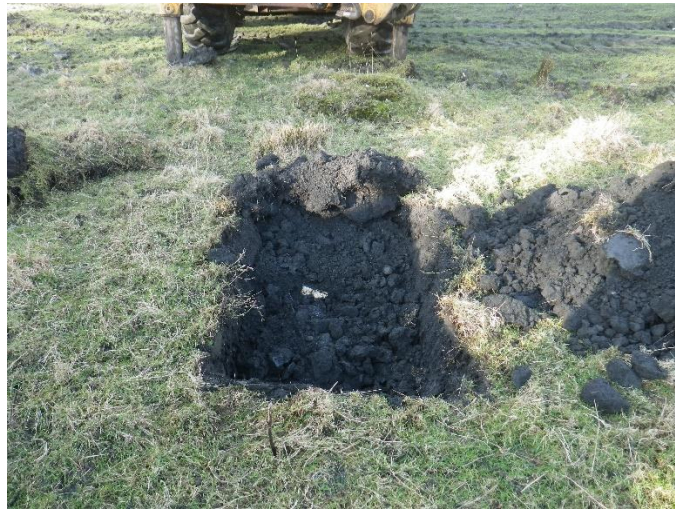
Fig. 8. TP2

- 4.2 TP2 was located on the east side of the modern graveyard in a natural hollow which is located on the south side of the stone enclosure wall (Fig. 1 & 8). The test pit was the same size as TP1 and roughly oriented NE/SW. The topsoil comprised a black clay loam with occasional rounded pebbles within it. Hard limestone bedrock was exposed at 0.40-0.45m depth. No archaeological deposits or artefacts were found.

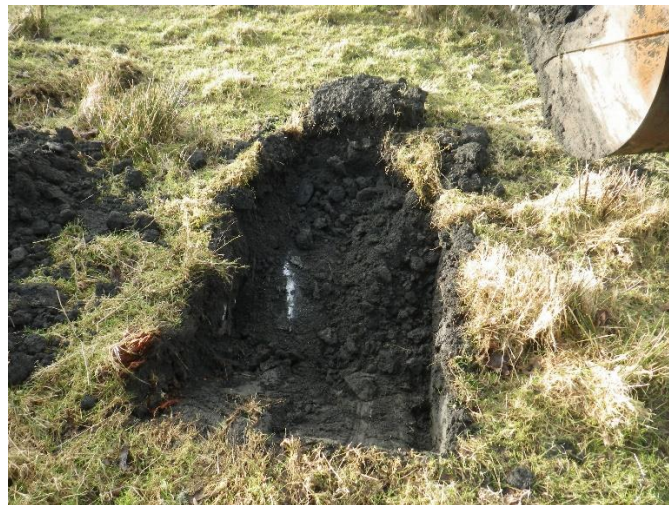
Fig. 9. TP3

- 4.3 TP3, 1.70m x 0.90m, was located to the south of TP2 (Fig. 1 & Fig. 9). The topsoil was again around 0.40m deep with hard limestone bedrock recorded just below the topsoil. No archaeological deposits or artefacts were found.

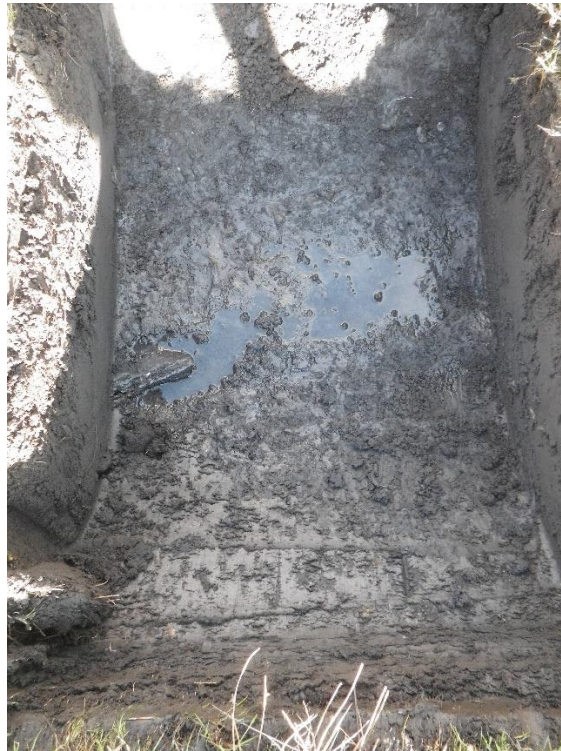
Fig. 10. TP4

- 4.4 TP4, 1.70m x 0.90m was located in the field on the east side of the main road and to the north of the presumed boundary of the early medieval graveyard (Fig. 1 & Fig. 10). The topsoil comprised a grey clay loam and was around 0.30m in depth. Below this was a compact grey clay. At a depth of c. 0.45m flecks of charcoal and red ash were observed adjacent to a clast of limestone which was partially located in the baulk. The ash deposit appears to have been dumped onto the clay 'surface'. Excavation was halted at this level.

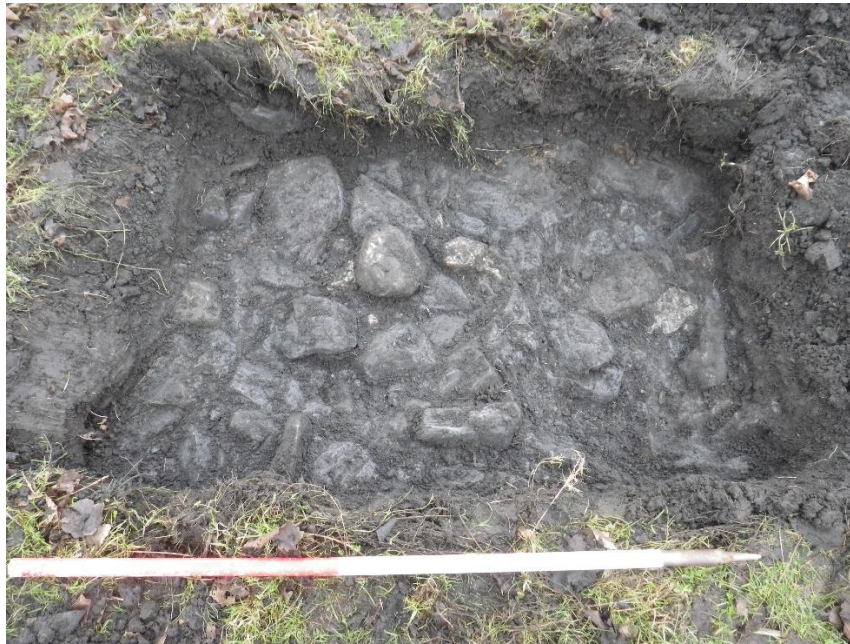
- 4.5 TP5, 1.30m x 0.90m was located to the east of the gate into the field. The topsoil was 0.21m deep and comprised a grey to black clay loam and was around 0.21m deep. Below the topsoil was a layer of limestone cobbles that had clearly been laid (Fig. 11). The limestone cobbles average 0.18m in length and there was some overlap and some stacking of the cobbles; 1 large cobble was removed by the machine and this stone was 0.45m long. A single small fragment of animal was observed within the sediment between the cobbles. Two rounded cobbles of quartzite had also been utilised in the surface. Excavation was halted at this level and the surface quickly clean and photographed.

Fig. 11. Cobble surface in TP5

- 4.6 The cobble surface in TP5 resembles that recorded against the eastern boundary of the glebe, Trench 7 and is clearly a deliberately laid surface; its extent was not ascertained. It is possible that this surface is part of the road as shown on the old estate map (See Ellis 2022, Fig 21) or it may be the remains of a surface entirely unrelated to the road. The ash in TP4 is roughly at the same level as the surface that capped the burials in Trench 12 which lay just a few metres to the south of the test pit (See Ellis 2022) and therefore may relate to medieval activity rather than the early medieval activity.
- 4.7 It is the recommendation of this report that if the development of Lismore Parish Church and/or the Church House proceeds then all associated groundbreaking work within the glebe should be subject to prior archaeological excavation and/or a watching brief.
